**CALSPAN ON-SITE AIR BAG DEPLOYMENT INVESTIGATION**

**CALSPAN CASE NO. CA95-08**

**VEHICLE #1 - 1995 FORD CONTOUR GL  
(DUAL AIR BAG-EQUIPPED)**

**VEHICLE #2 - 1994 DODGE INTREPID  
(DUAL AIR BAG EQUIPPED)**

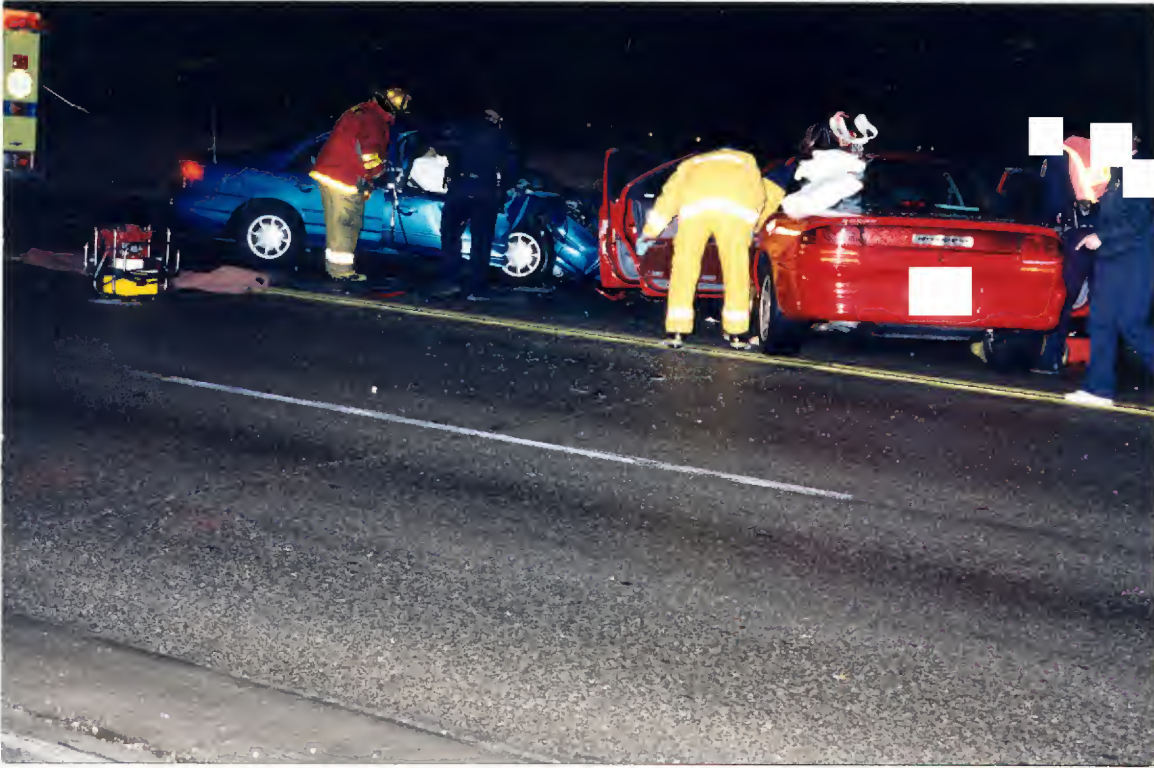
1. On-scene photograph of Vehicle #1 [1995 Ford Contour GL (Blue)] and Vehicle #2 [1994 Dodge Intrepid (Red)] at final rest positions (FRP).

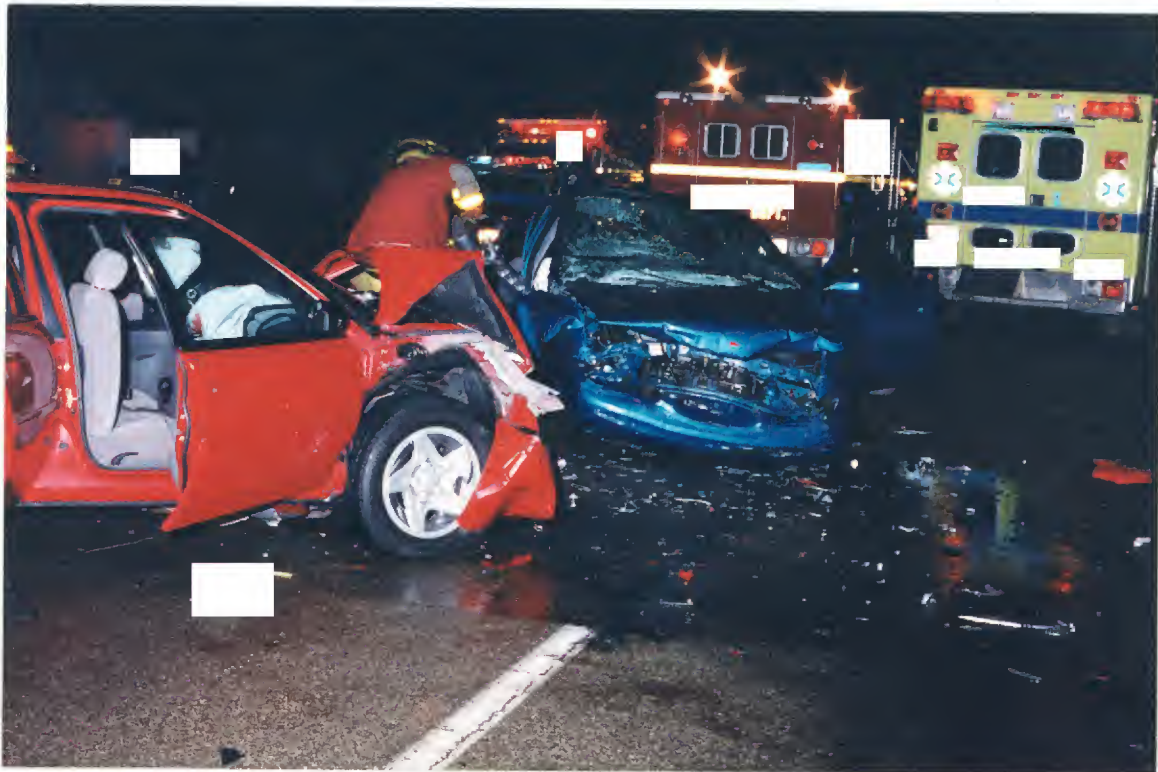
2. View of both vehicles at FRP looking north. Both vehicles came to rest in the left northbound lane.

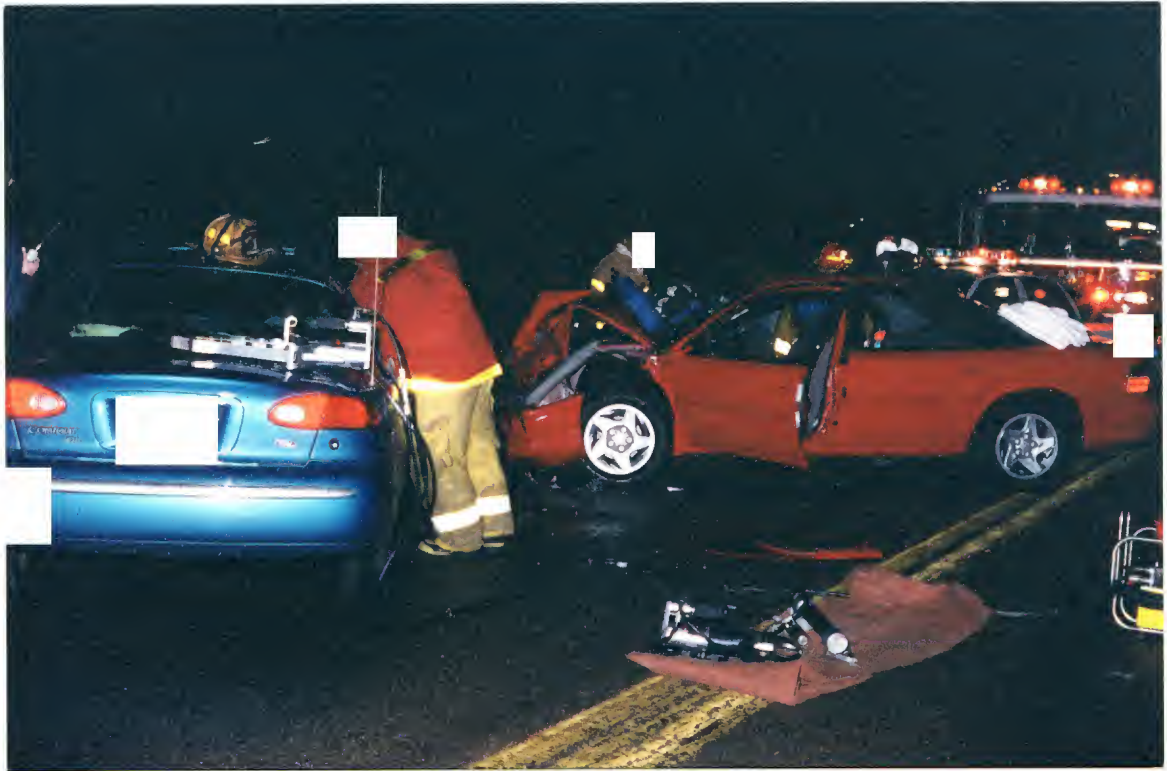
3. View of the vehicles from the left southbound lane.

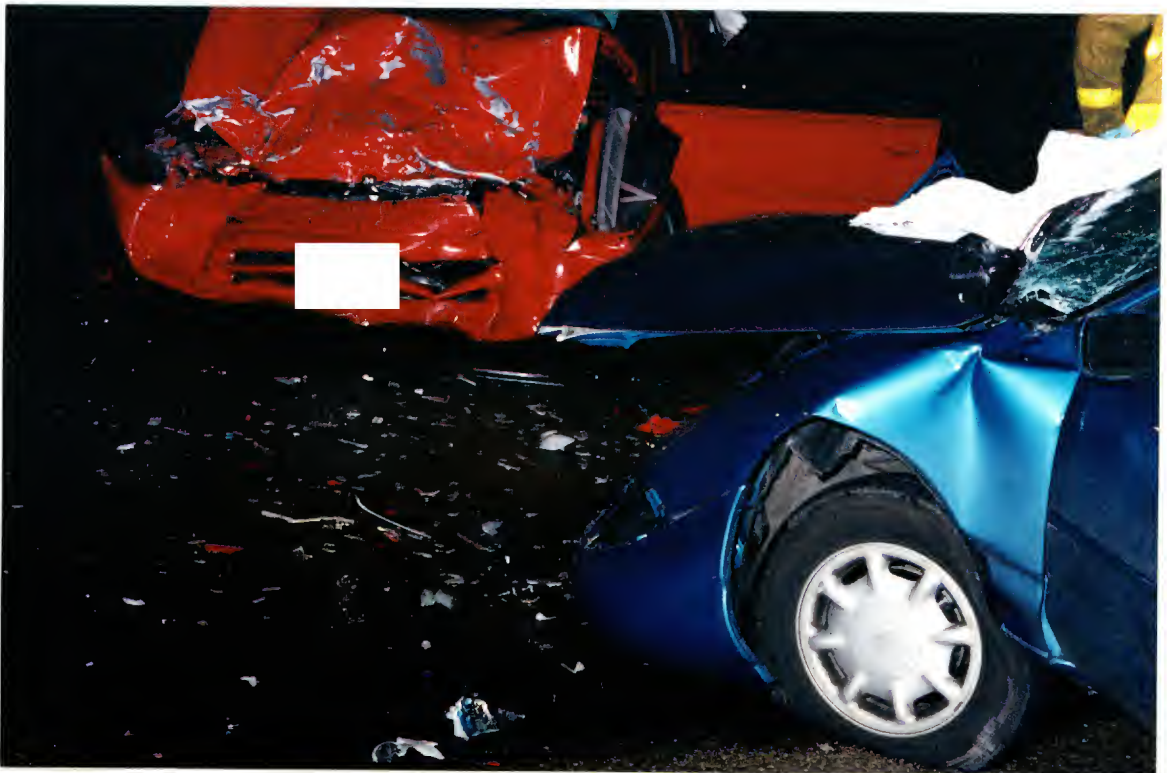
4. View of both vehicles at FRP looking west.

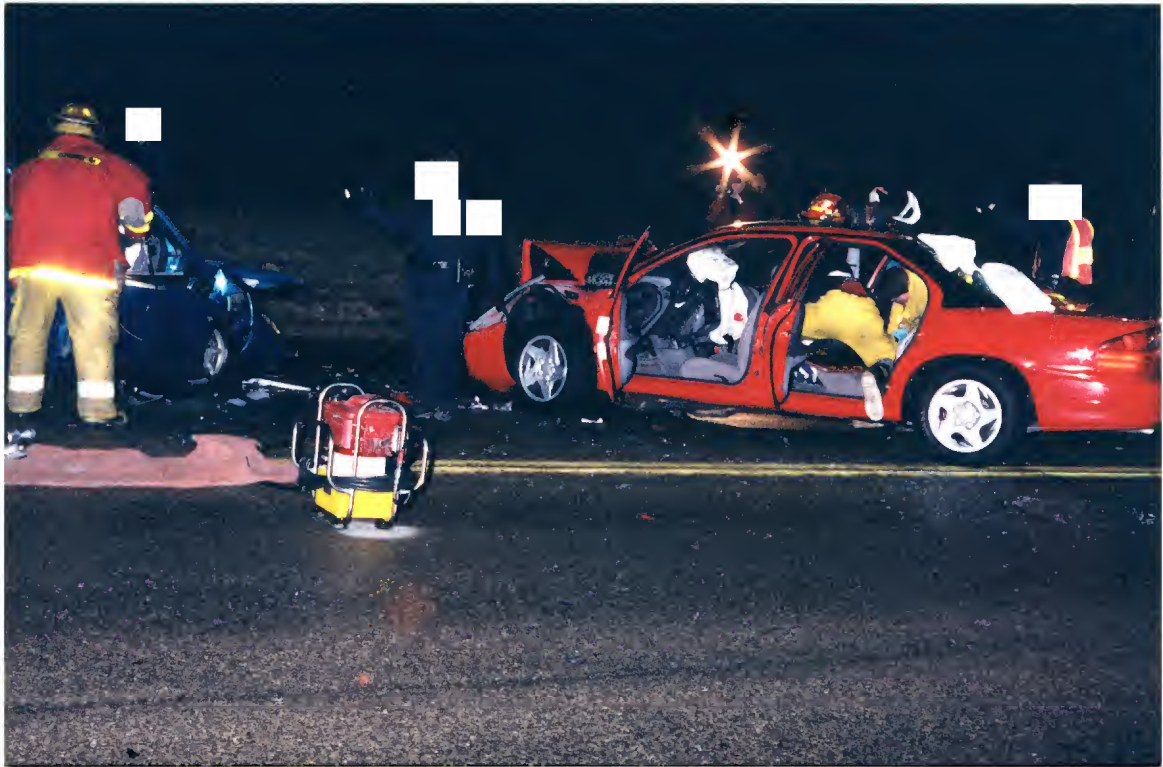
5. View of both vehicles at FRP looking east.

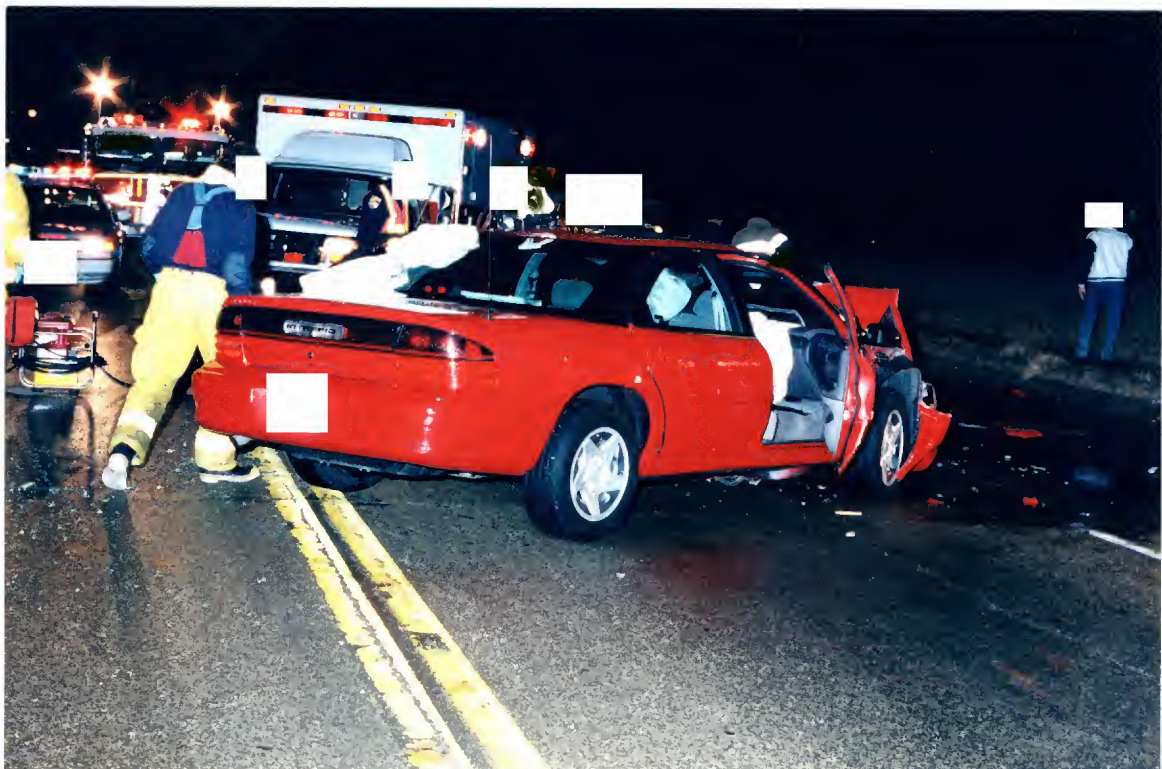
6. View of Vehicle #2 at FRP looking north from the left southbound lane.

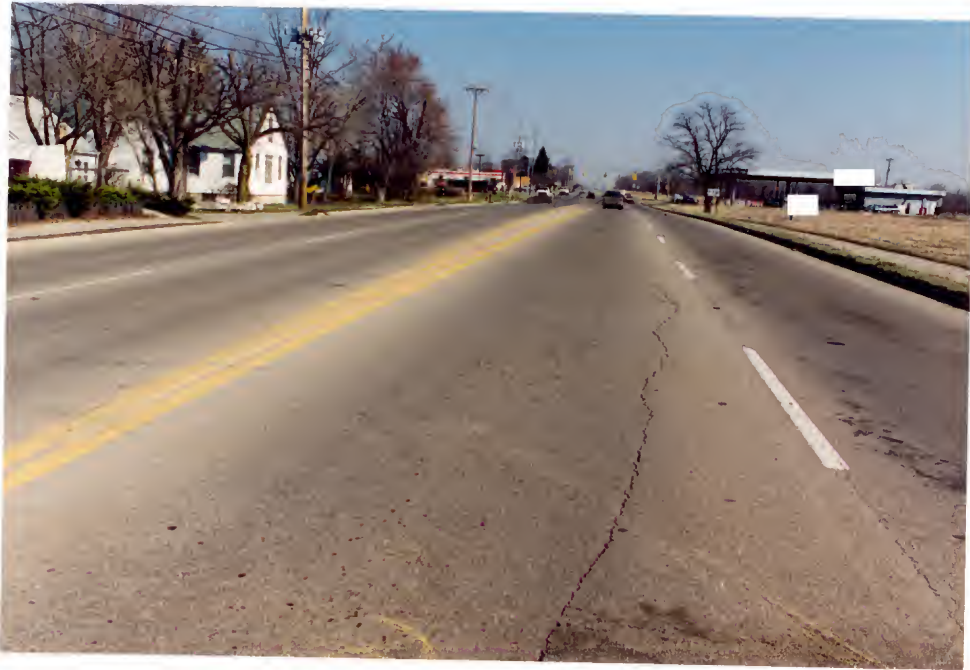
17. Reverse view of Vehicle #1's trajectory from the POI.

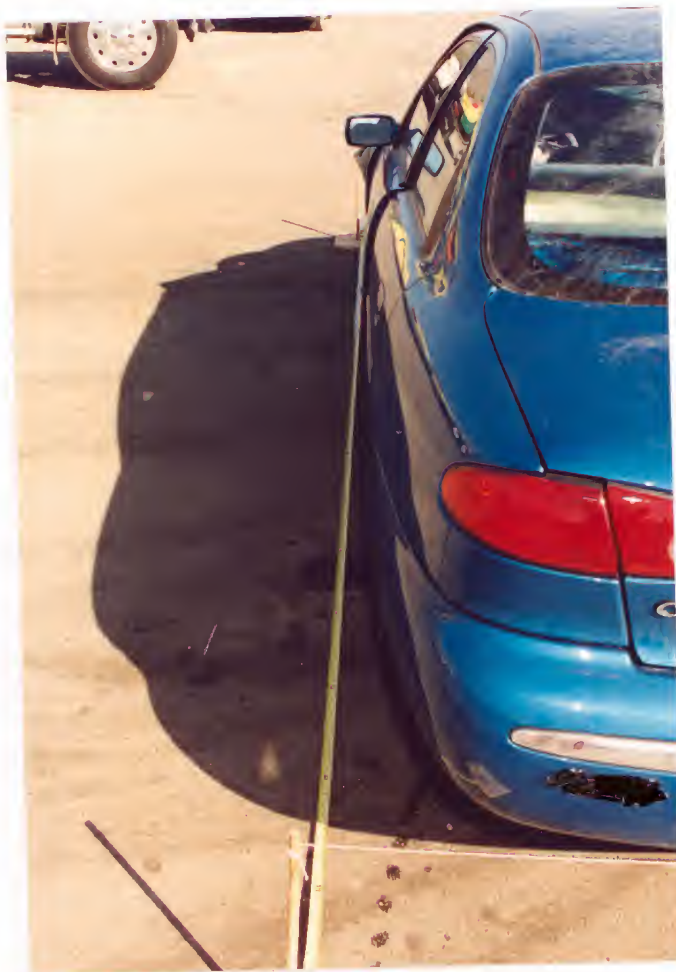
44. Longitudinal view from the left rear bumper of Vehicle #1 highlighting the lack of outward lateral movement of the vehicle structure.

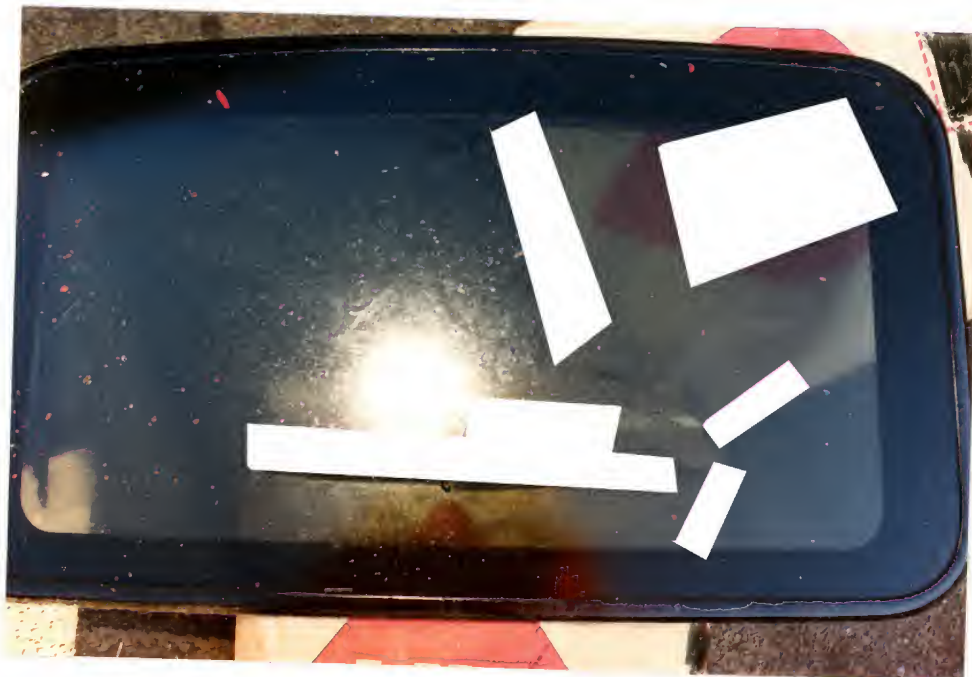
56. View of the sun roof AS-3 glazing which separated from Vehicle #1 during the crash. Red paint chips matching the color of Vehicle #2 were present on the glazing surface.

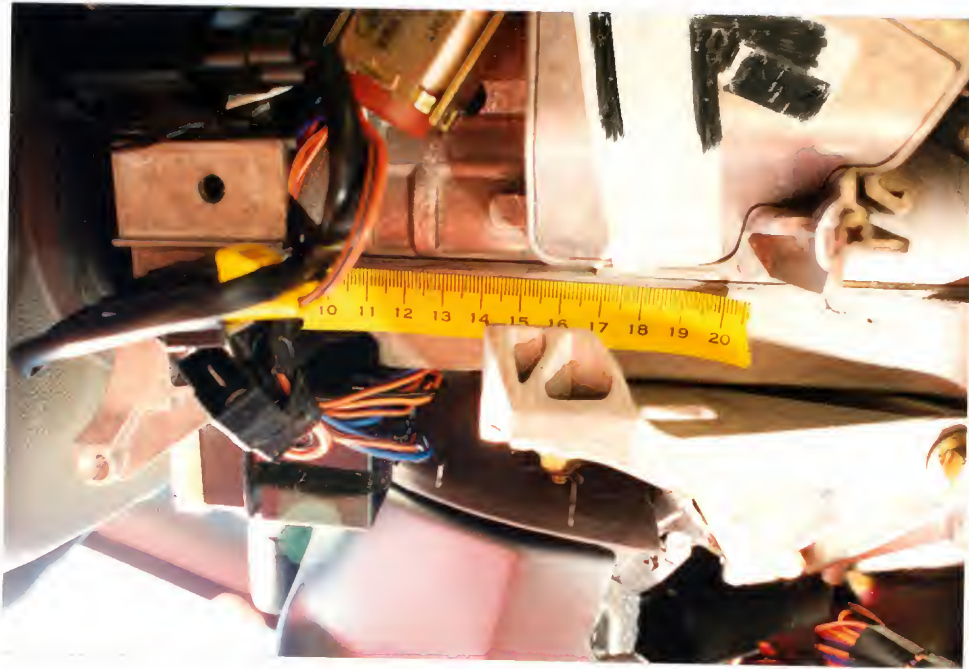
69. View of the steering column slip joint which was displaced 7.0 cm (2.8"). The original placement of the column was located at the spot marked by the No.10 on the calibrated yellow tape. The steering wheel is oriented at the left side of the photograph.

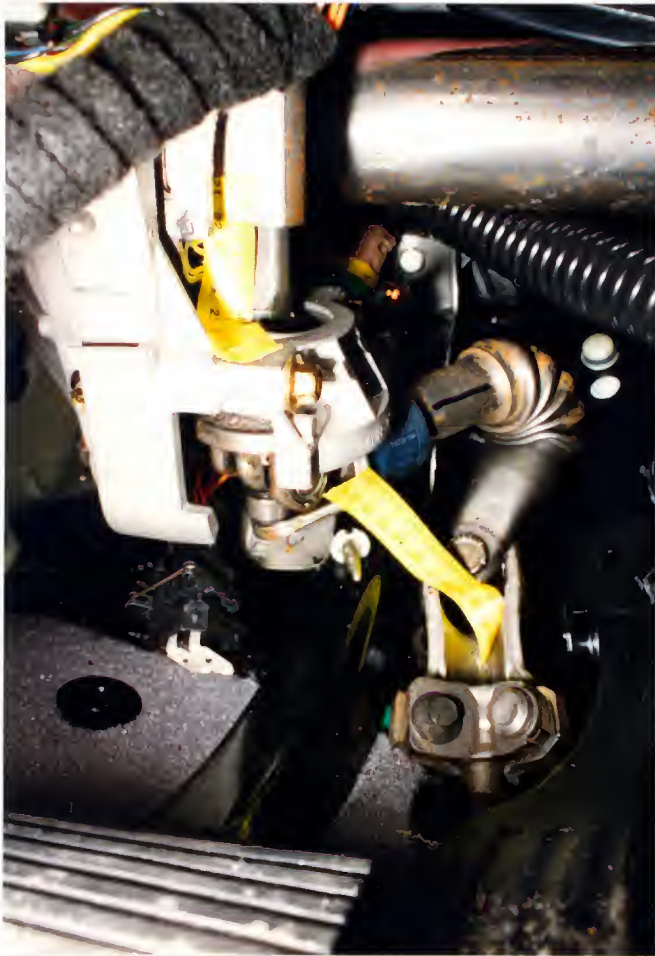
70. View of the lower portion of the steering column highlighting the steering column energy absorbing device (noted by the yellow calibrated in the upper area of the photograph) and the offset convoluted steering column (noted by the yellow calibrated tape in the lower portion of the photograph).

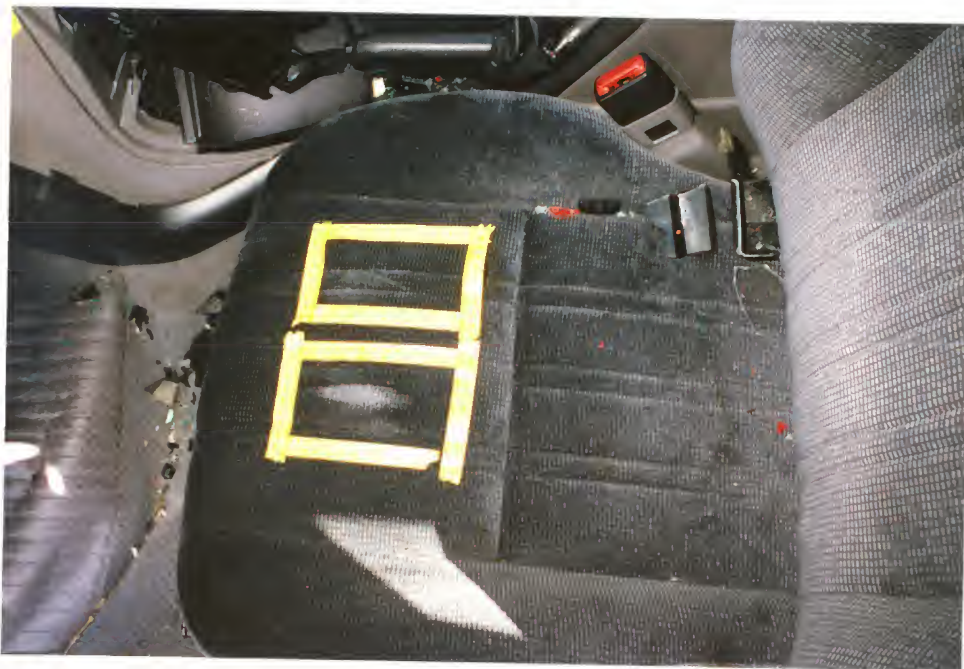
71. View of the abraded fabric on the driver's seat resulting from contact by the driver's left and right upper legs and buttocks.

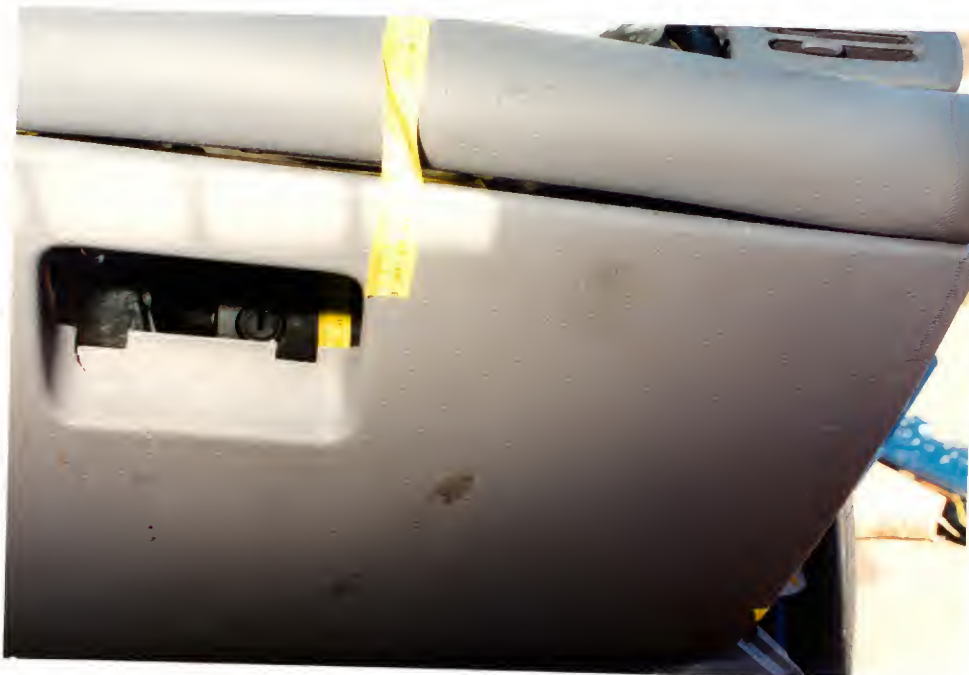
76. Close-up view of plastic glove compartment panel.

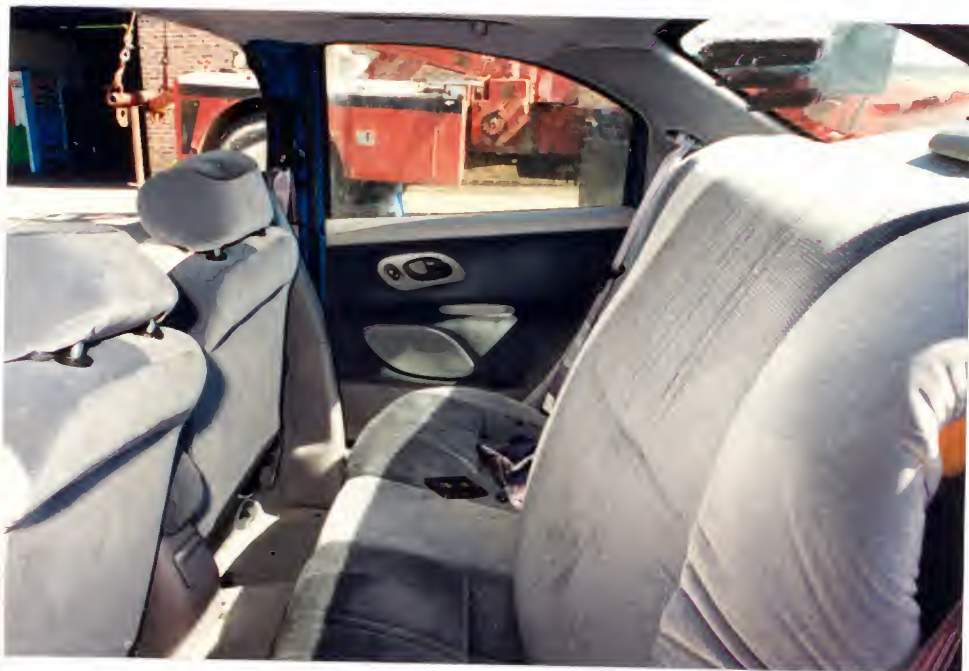
96. View of the rear seat area from the left side of the vehicle.

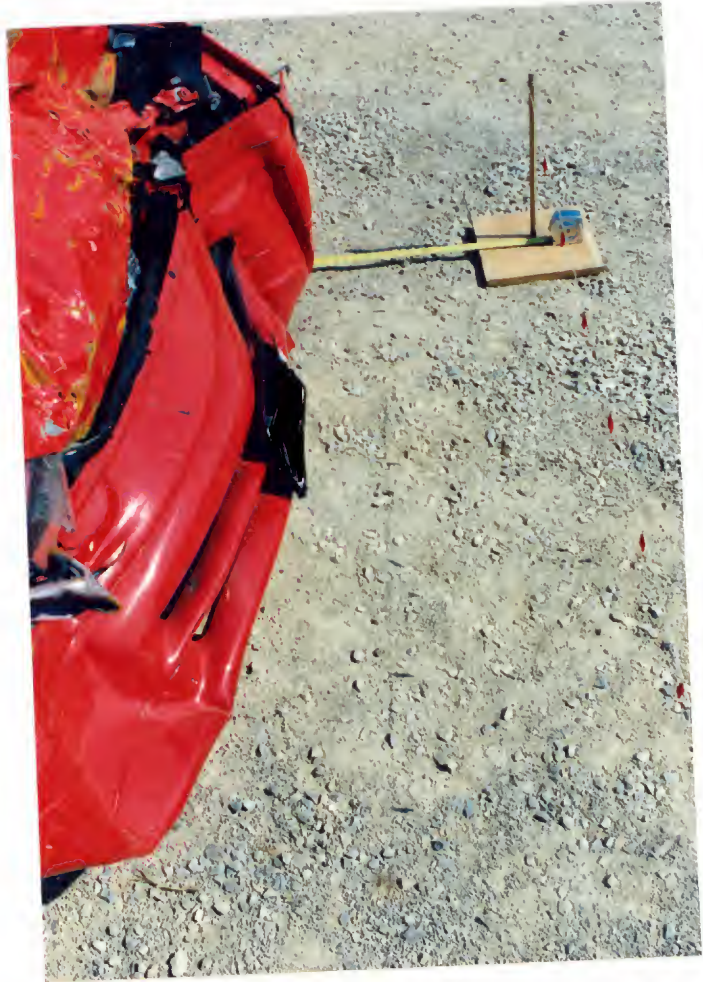
102. Left front corner view of Vehicle #2.

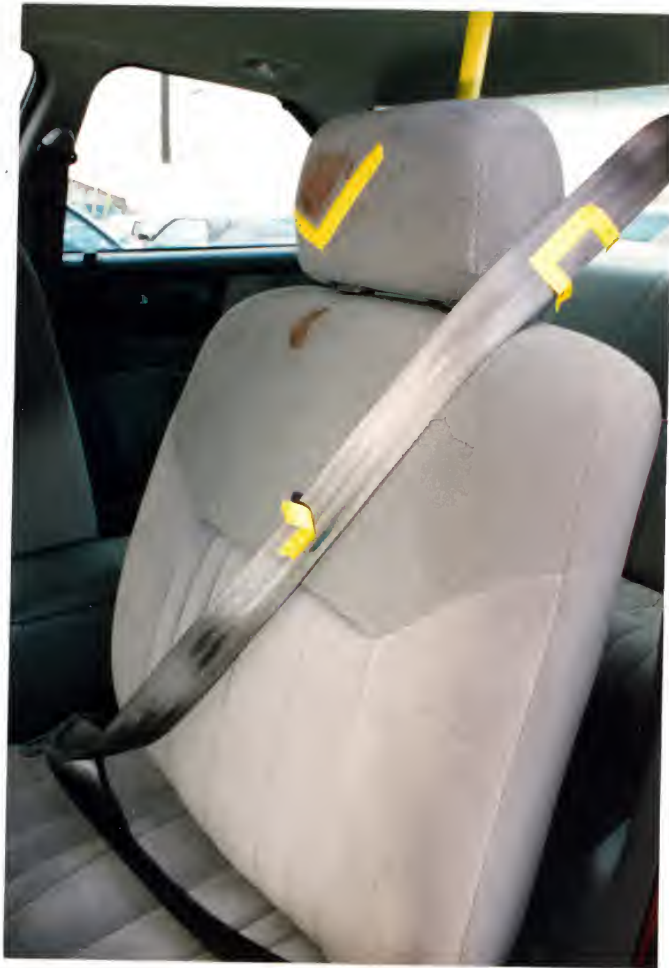
114. Close-up view of the bodily fluid marks on the driver side head restraint and seat back rest.

The front surface of the head restraint exhibited a 5.1 cm (2.0") diameter bodily fluid transfer which was attributed to the driver's head. It was located 6.4 cm (2.5") below the top of the head restraint and 5.1 cm (2.0") left of the inboard edge. Directly below the head restraint on the front surface of the seat back support was another bodily fluid artifact which was also associated with the lesion from the posterior aspect of the driver's head. This artifact was located 3.8 cm (1.5") below the top of the seat back support and 18.4 cm (7.25") left of the inboard seat back support edge.

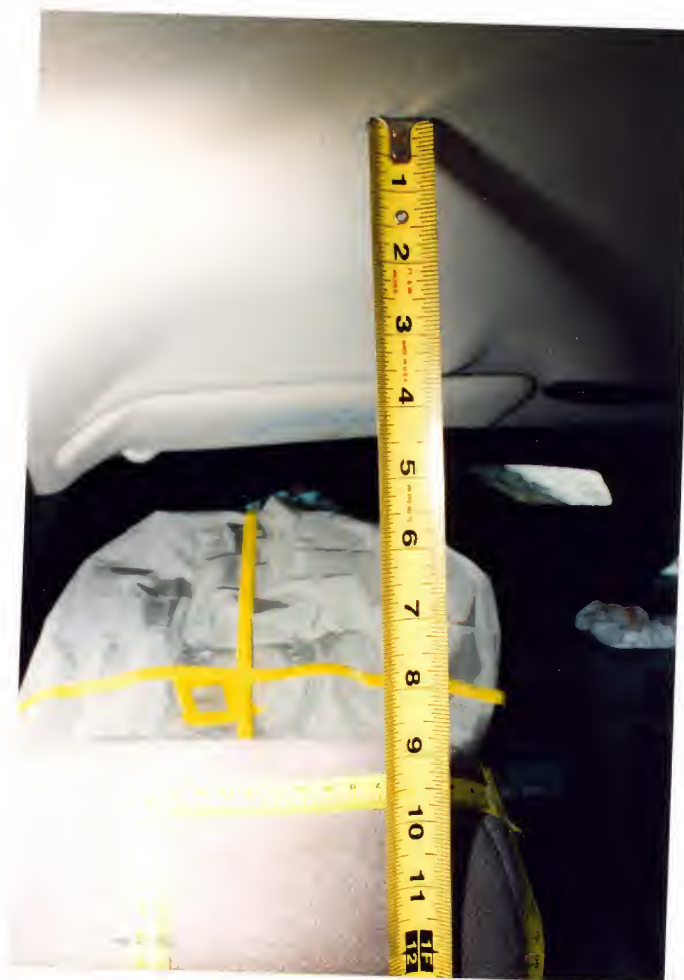
140. Close-up view of a contact pattern on the back side of the left front head restraint.

The rear surface of the left front seat back support was deformed as the result of contact by the unrestrained 7 year old female left rear occupant. The top inboard rear portion of the head restraint was loaded by the left rear occupant as noted by a 12.7 cm x 7.6 cm (5.0" x 3.0") reddish brown transfer. As the top of the head restraint was displaced forward, the upper portion of the head restraint guide posts pivoted against the top of the seat back support resulting in the rearward movement of the lower portion of the guide posts. The combination of the head restraint rotation and subsequent contact by the child's upper body resulted in the protrusion of the head restraint guide posts through the seat fabric. The punctures in the seat back support were located 10.8 cm (4.25") below the top of the seat back support.

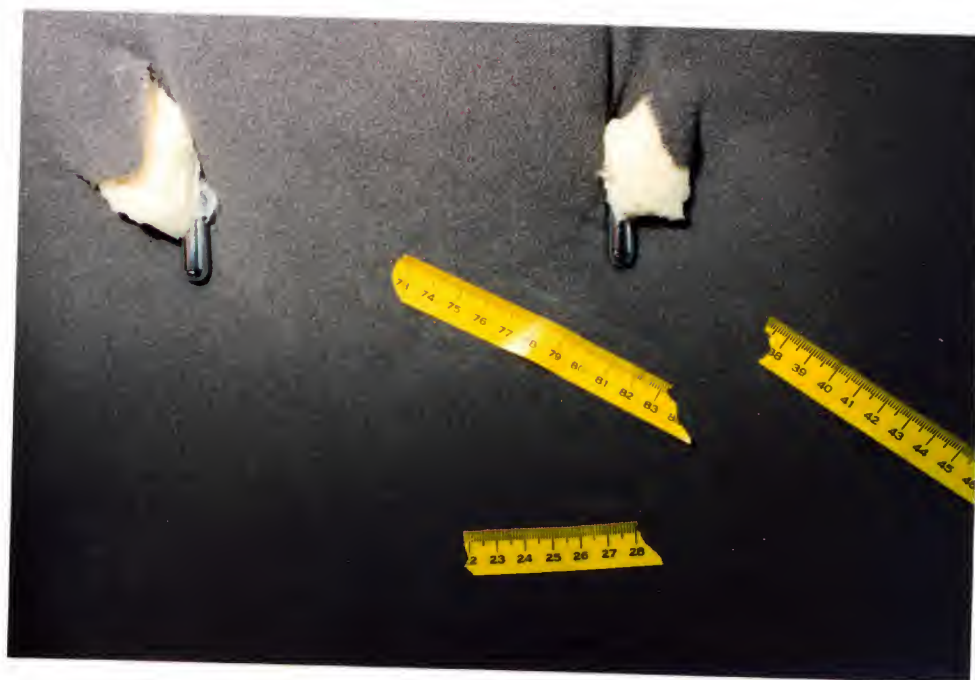
142. Close-up view of the center of the left seat back rest highlighting the protruding head restraint height adjustment posts and contact evidence.

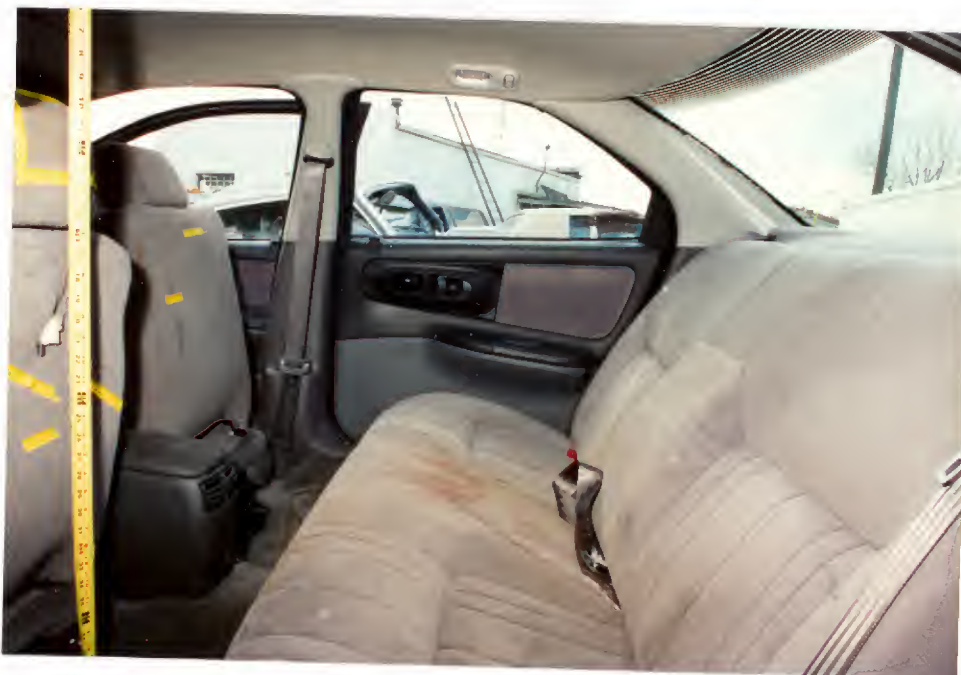
145. Lateral view of the rear seating area looking from the left side of the vehicle.

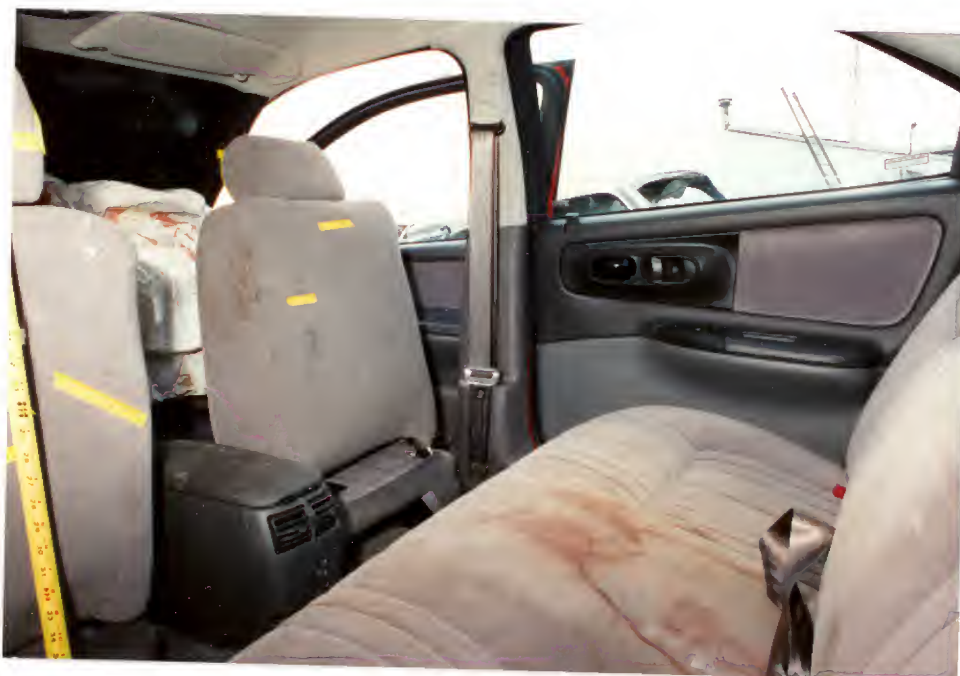
146. Angular view of the rear seating area which focuses on the right rear occupant space and contact evidence on the back side of the right front seat back rest.

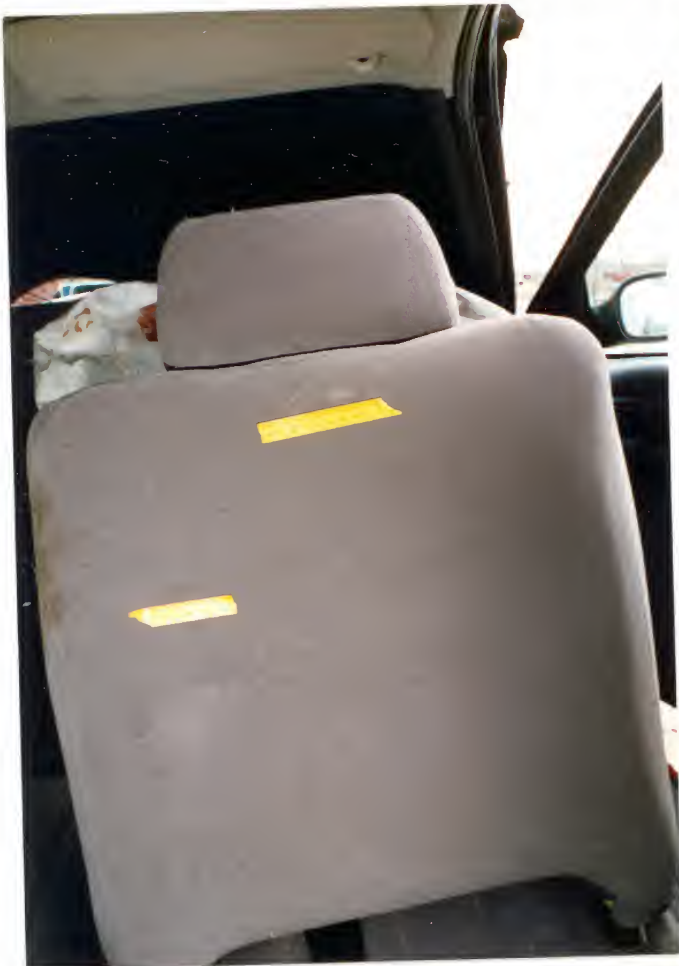
148. Closer view of contact evidence on the back surface of the right front seat back rest.

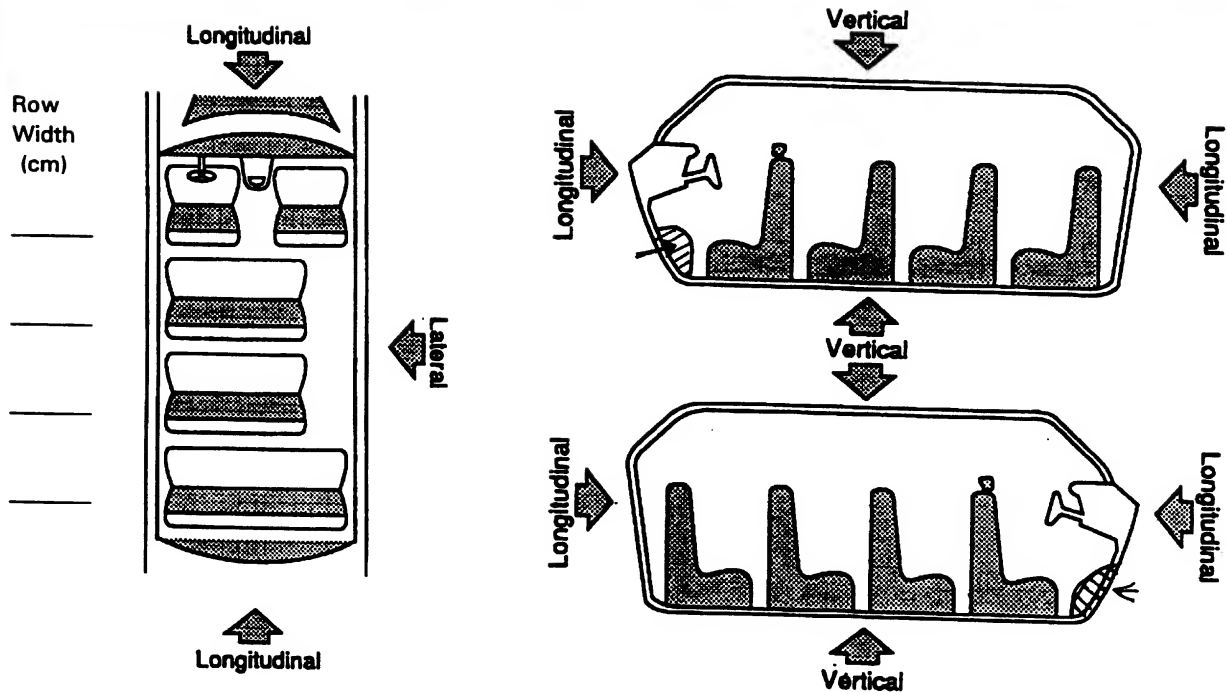
LOCATION OF INTRUSION	INTRUDED COMPONENT	(All Measurements Are In Centimeters)			DOMINANT CRUSH DIRECTION
		COMPARISON VALUE	INTRUDED VALUE	INTRUSION	
11	Toe pan / floor pan located @ forward edge of plastic mat	Toe pan adjacent to plastic mat foot rest 116.2cm (45.8")	81.3cm (32.0")	34.9cm (13.8")	Longitudinal
	edge of plastic mat 40.6cm (16") L of &	Plastic mat foot rest 108.7cm (42.8")	81.3cm (32.0")	27.4cm (10.8")	Longitudinal

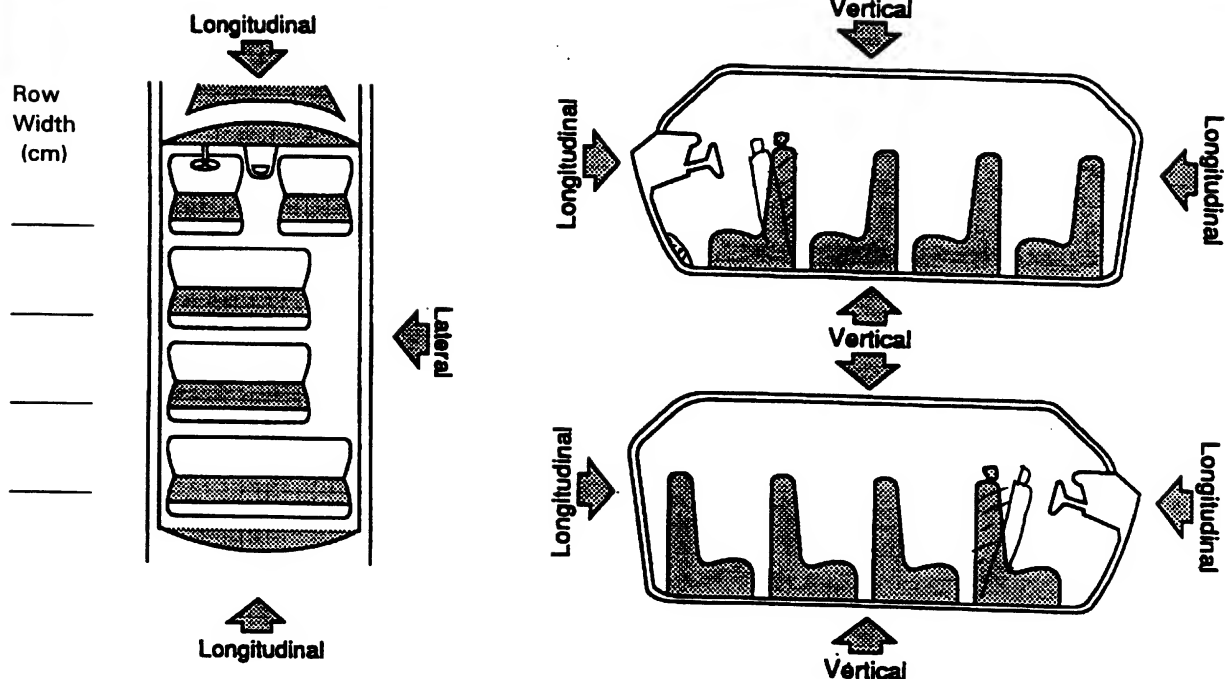
LOCATION OF INTRUSION	INTRUDED COMPONENT	(All Measurements Are In Centimeters)			DOMINANT CRUSH DIRECTION
		COMPARISON VALUE	INTRUDED VALUE	INTRUSION	
11	Toe Pad - Adjacent to other foot rest pad	114.9cm (45.25")	95.3 (37.5")	= 19.6 cm (7.7")	Long
11	Seat back Support	-	-	= 15.2 cm (6.0")	Long
12	Driver Instrument Panel, lower edge of console, (center console)	67.3cm (26.5")	63.8 cm (25.125")	= 3.5 cm (1.4")	Long
13	Toe Pad @ base of console	105.4cm (41.5")	77.5cm (30.5")	= 27.9 cm (11.0")	Long
13	Seat back Support	-	-	= 25.4 cm (10.0")	Long
		-	-	=	
		-	-	=	
		-	-	=	
		-	-	=	
		-	-	=	
		-	-	=	
		-	-	=	
		-	-	=	
		-	-	=	
		-	-	=	
		-	-	=	
		-	-	=
